2.0 EXECUTIVE SUMMARY

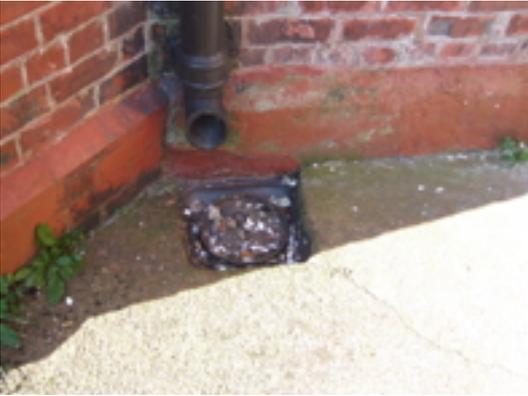
Sump with debris south east corner

Clean debris from sumps generally and realign covers and remove vegetation

Unblock sump by Vestry

Approach Ecclesiastical Insurance to organise inspection of blocked sump to Boiler chamber and inspection of pipework for tree root damage.

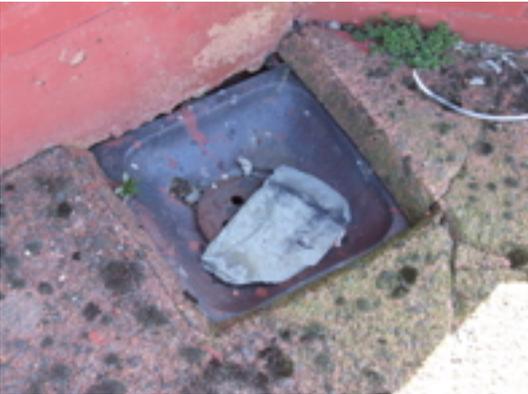
Sump with debris

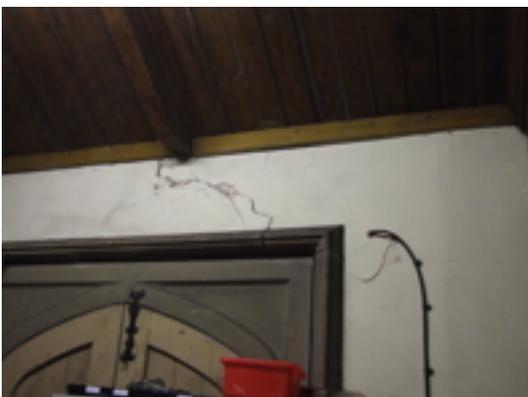
There is severe cracking above and around the external doors to the East Aisle Store but this appears to be historic as there are no signs of movement externally. There is some cracking around several of the windows but again this appears to be historic as there are no signs of movement externally.

Cracking above and around East Aisle Store external doors

Hack off and replaster all loose areas with a limelight renovating plaster. Decorate all walls. Note if a change of paint colour or paint type is required then this will require Faculty Approval.

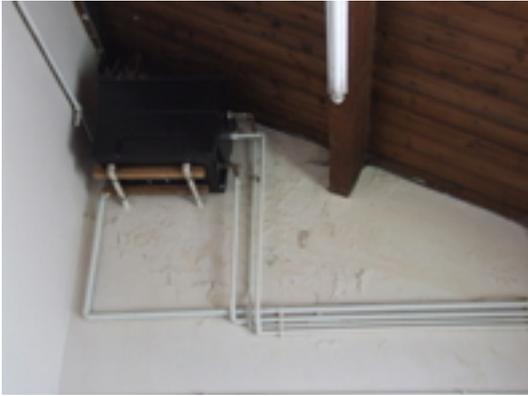
There is flaking paint at high level in the Vestry probably associated with the displaced flashings externally.

Flaking paint to Vestry north wall

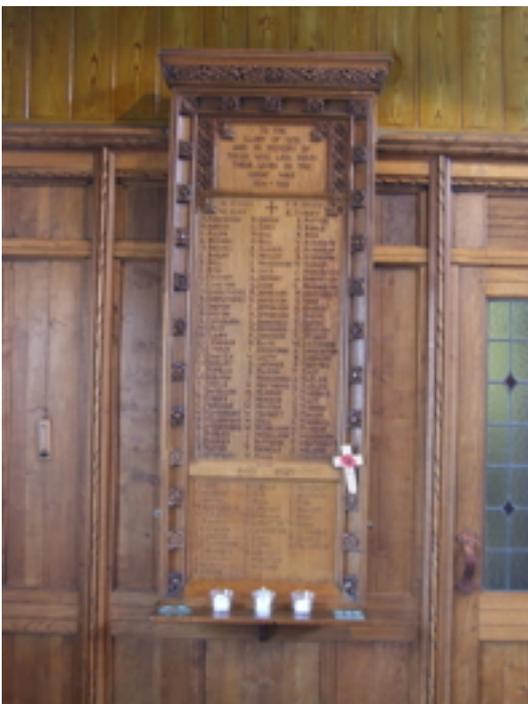
World war one and world war two memorial

Decorate all walls and doors as part of redecorating works to the church.

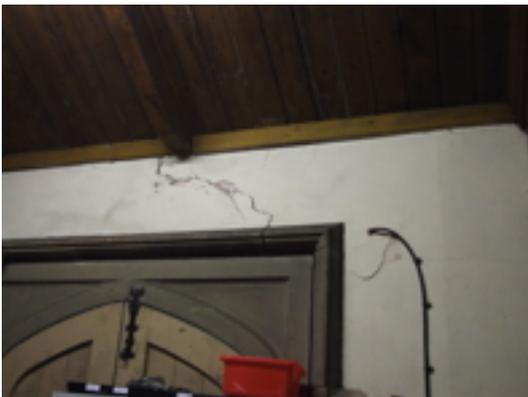
There is severe cracking around the external door but no signs of similar externally so I am happy to consider this is historic. There is loose plaster at high level to the north elevation which indicates damp but with the walls and copings having been repointed and the roof is reasonable condition I am happy to consider this is historic.

East Aisle Store cracking

The walls and doors would benefit from decoration following the filling of the cracks and making good of the plasterwork. The flooring needs replacing.

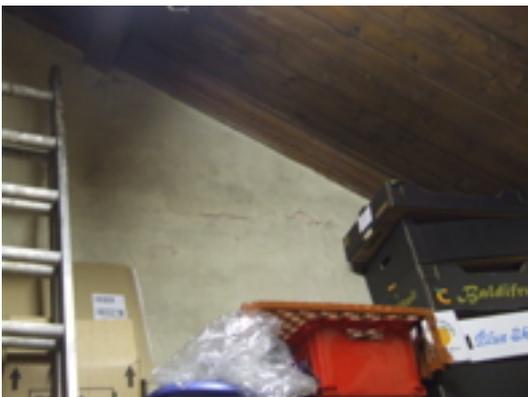
East Aisle Store loose plaster

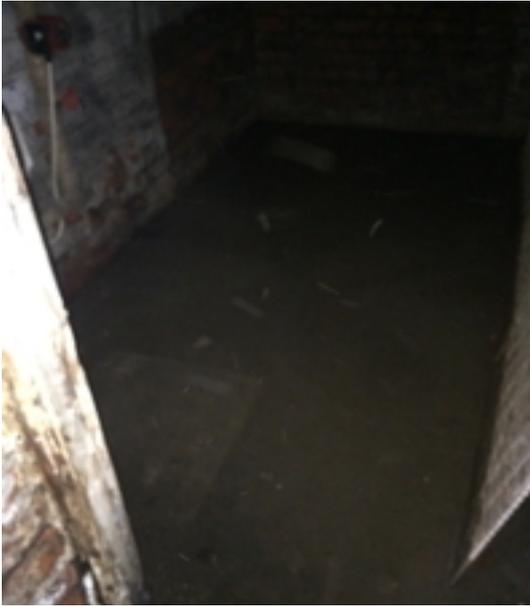
Boiler Chamber From Bottom of Staircase showing pump on west wall

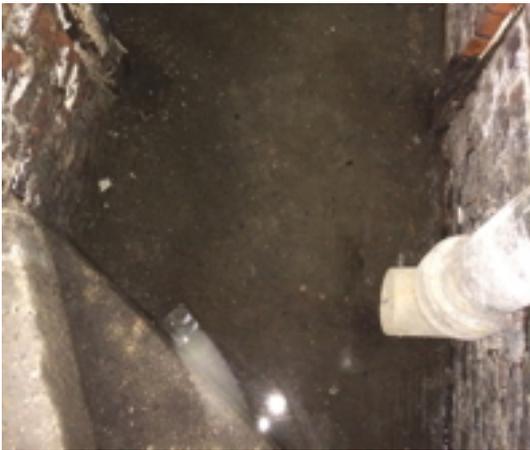
Boiler Chamber with blocked sump below redundant rainwater pipe.

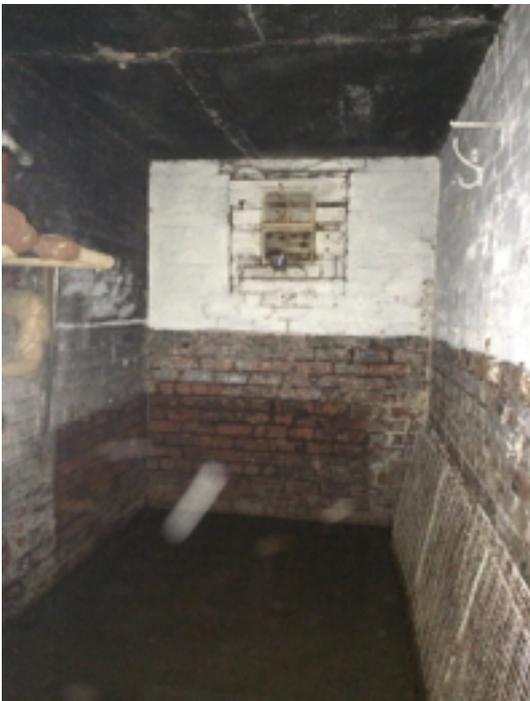
Boiler Chamber.

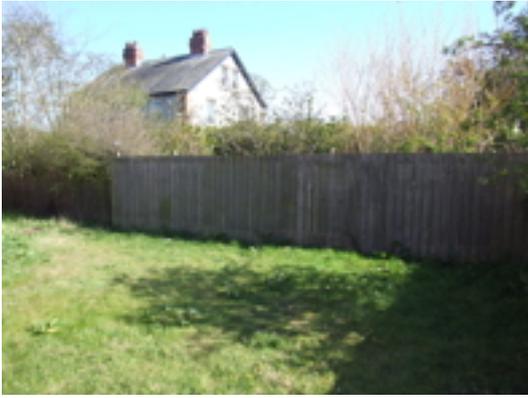
Eastern boundary fence south end

Confirm maintenance responsibility for eastern fence and repair/replace as necessary.

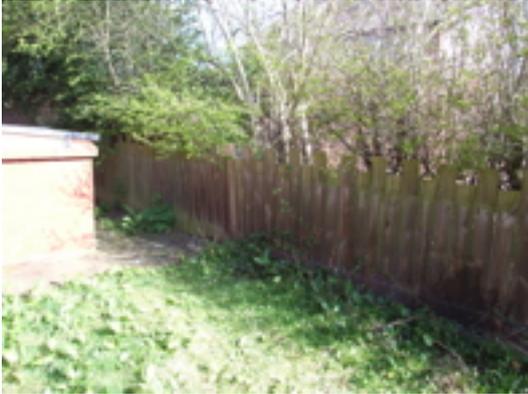
Eastern boundary fence central section

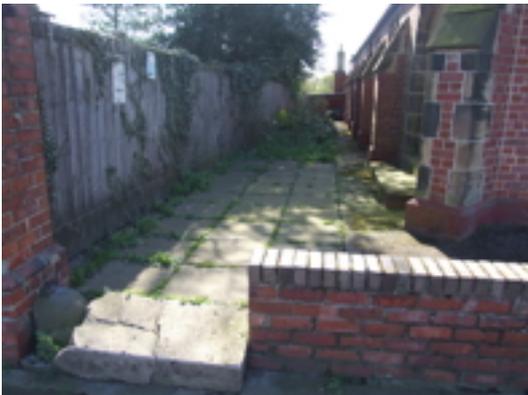
Eastern boundary fence northern section

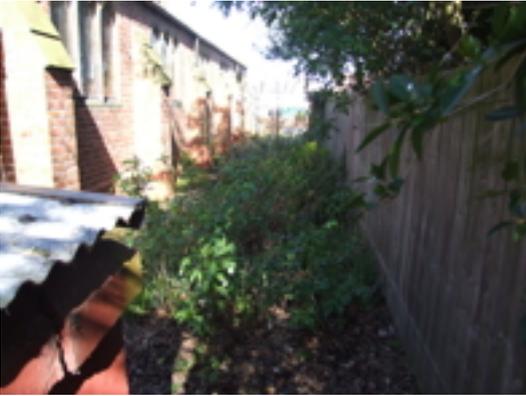
Shrubs to eastern boundary middle section

Apply weedkiller to all areas as necessary.

Consider a scheme to fence off eastern areas to remove public access and reduce vandalism.
Consider the landscaping, especially to the west elevation, to make it more attractive.

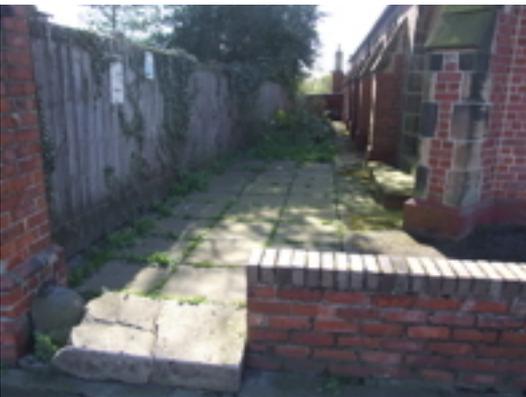
Paving to eastern boundary to north end

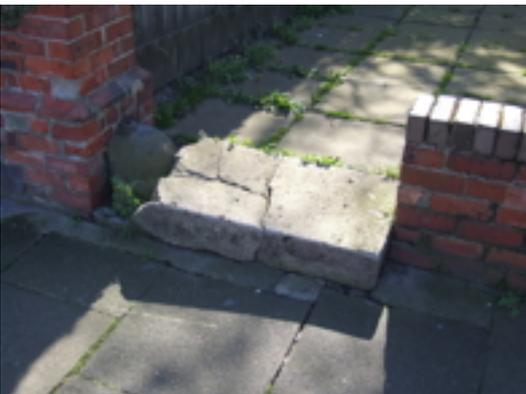
Broken step to northern boundary

Reform broken step to northern boundary to remove trip hazard.

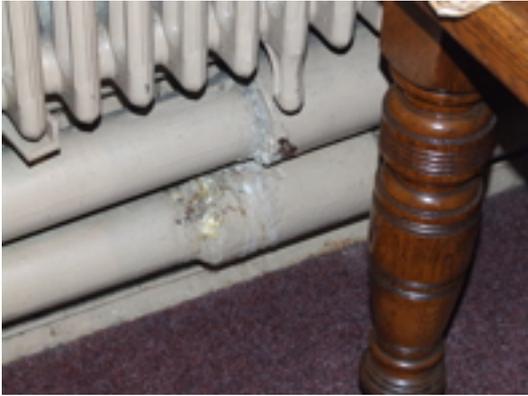
Leaking Heating Pipework

Monitor heating pipework and radiators for leaks.
